# **BioMax Environmental**

**Department of General Services  
Board of Equalization Building, 450 N. Street  
22<sup>nd</sup> Floor Post Mitigation Final Assessment  
Sacramento, California**

November 10<sup>th</sup>, 2008BOE Building 22<sup>nd</sup> Floor-Wide Post Mitigation Assessment  
Sacramento, CA[Click here for color photos](#)

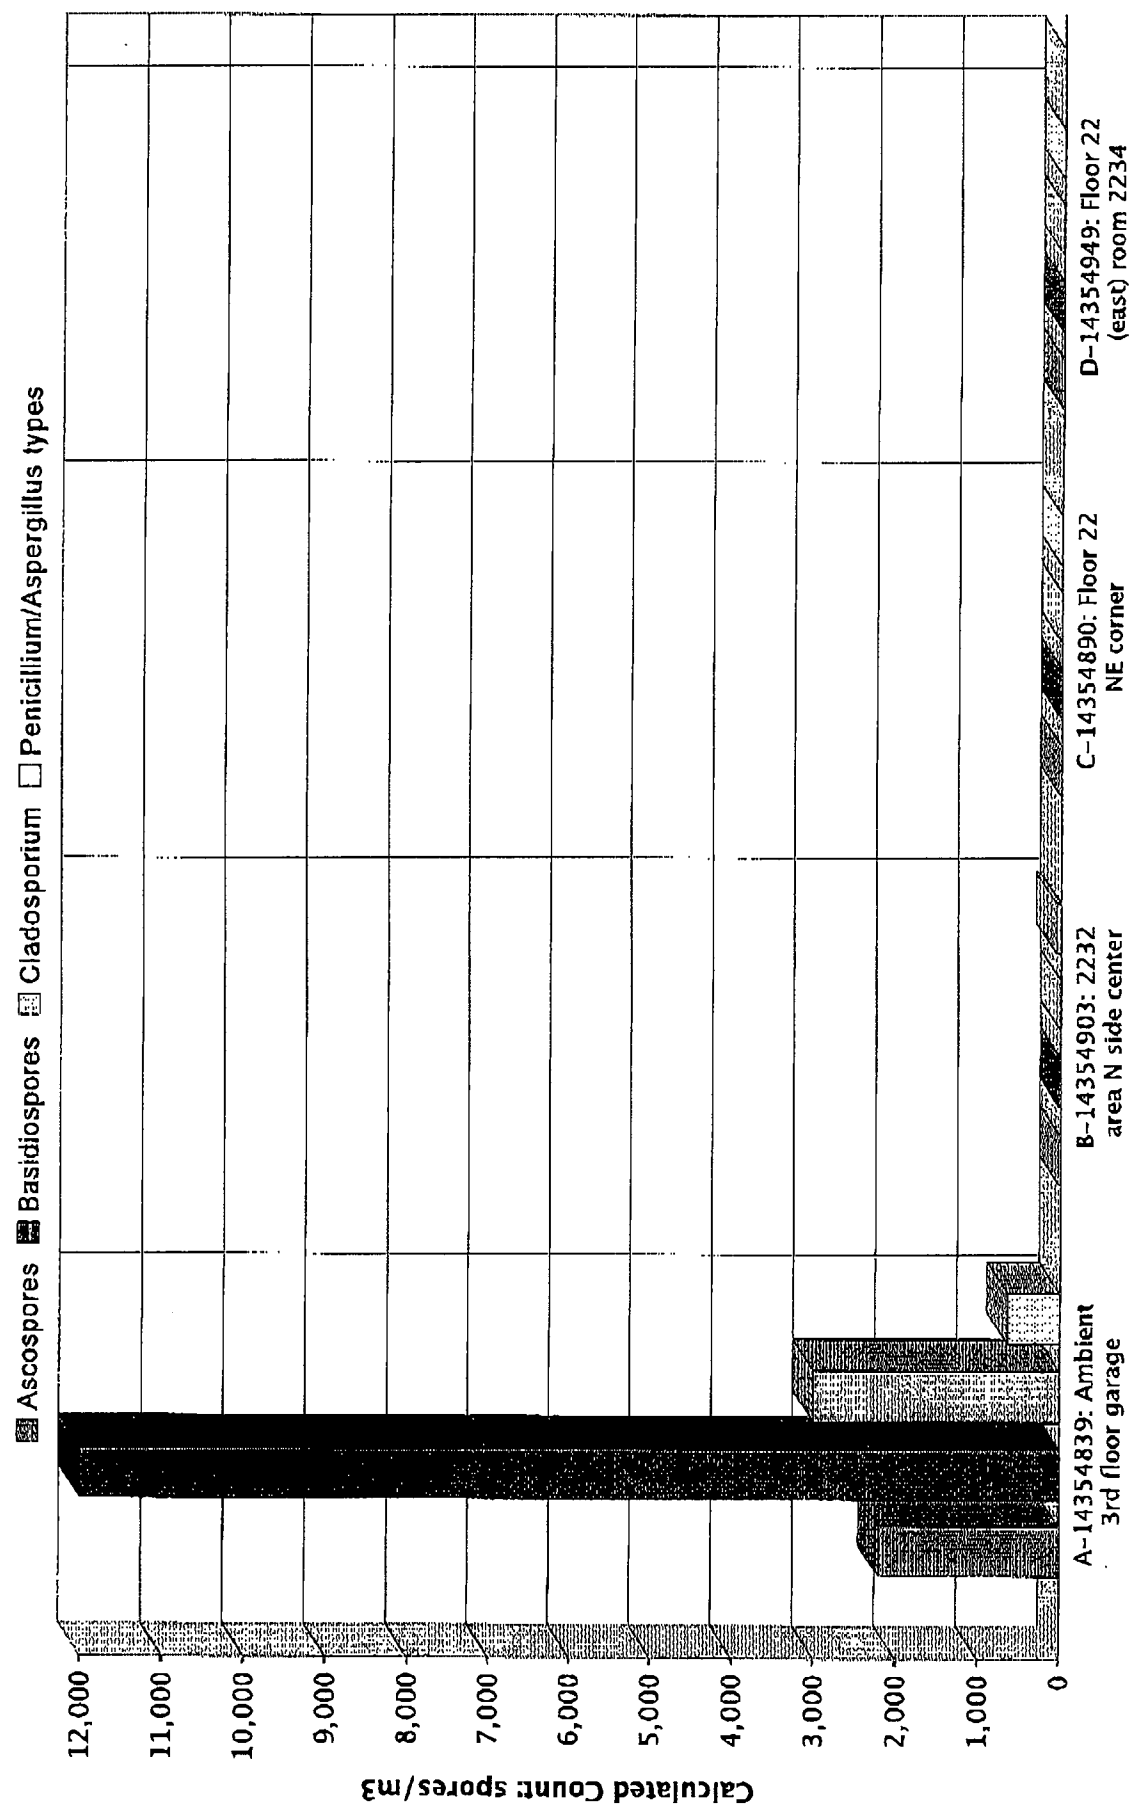
SPORE TRAP REPORT: NON-VIABLE METHODOLOGY

Note: Graphical output may understate the importance of certain "marker" genera.  
TestAmerica Environmental Microbiology Laboratory, Inc.

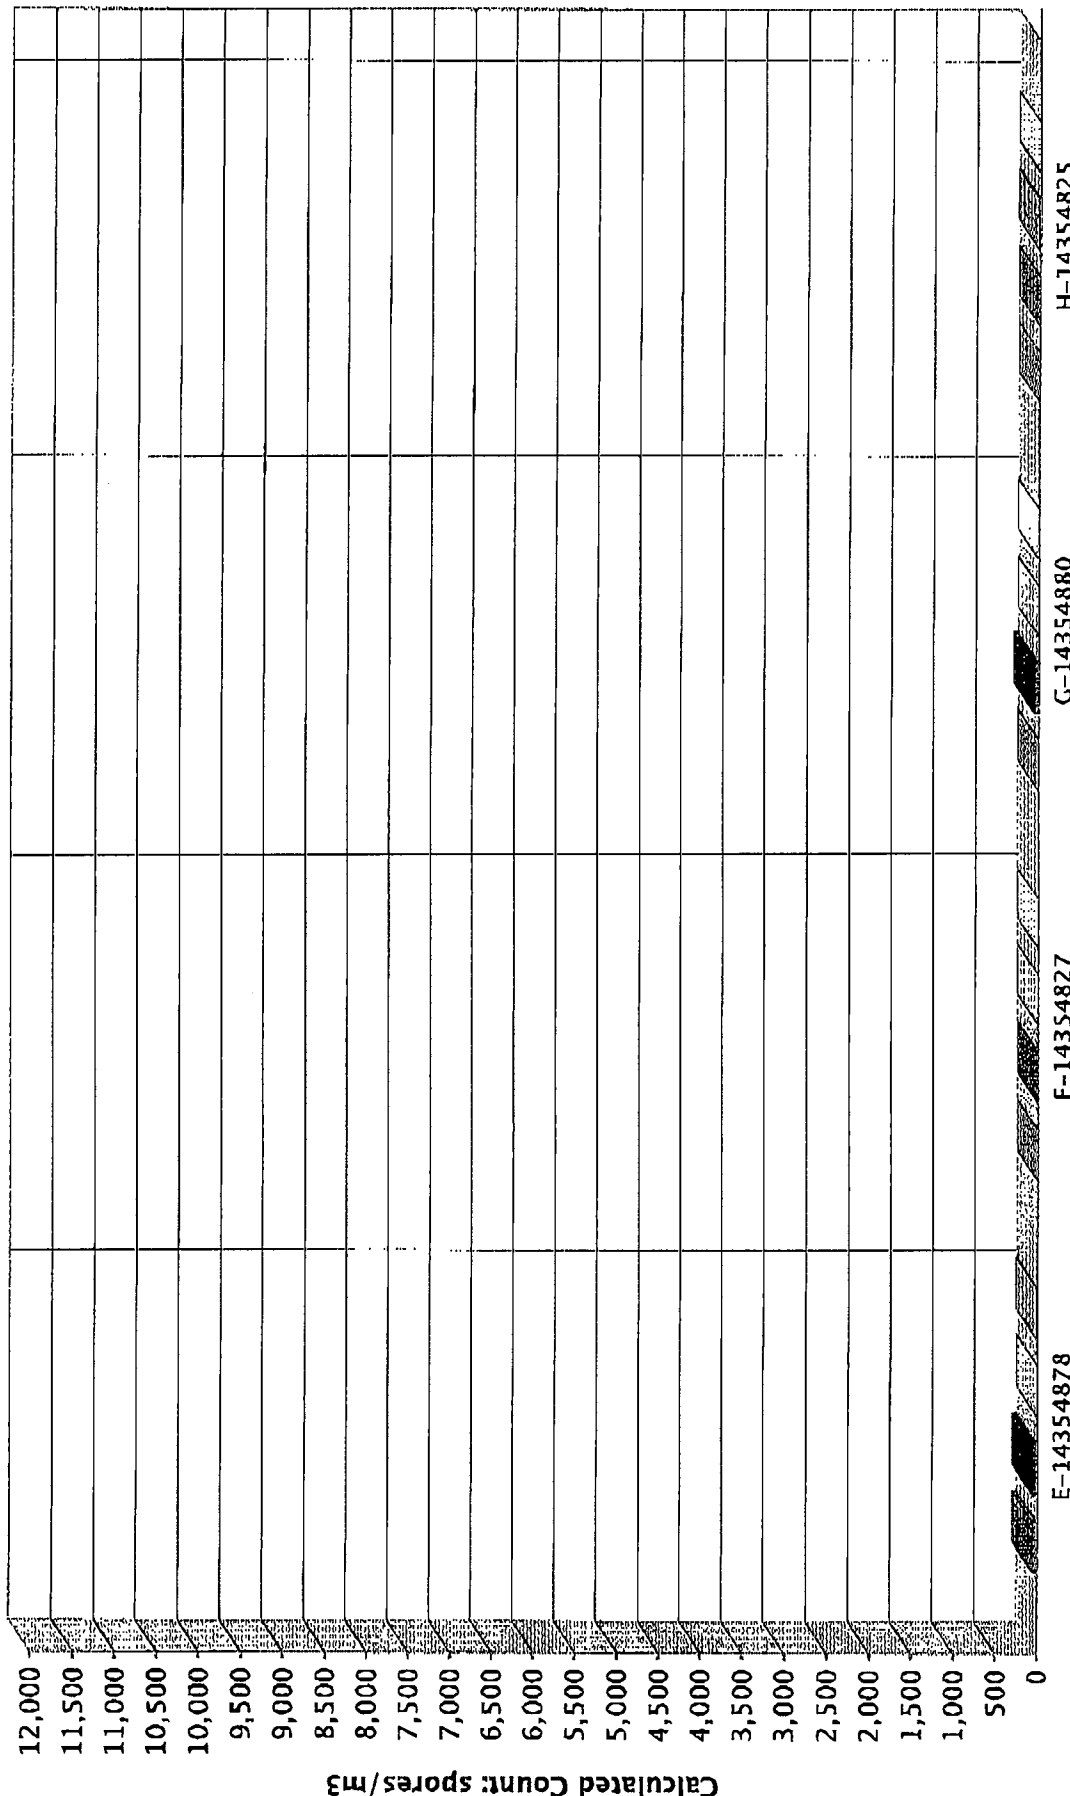
SPORE TRAP REPORT: NON-VIABLE METHODOLOGY

Ascospores Cladosporium Rusts Smuts, Periconia, Myxomycetes

Note: Graphical output may understate the importance of certain "marker" genera.  
TestAmerica Environmental Microbiology Laboratory, Inc.

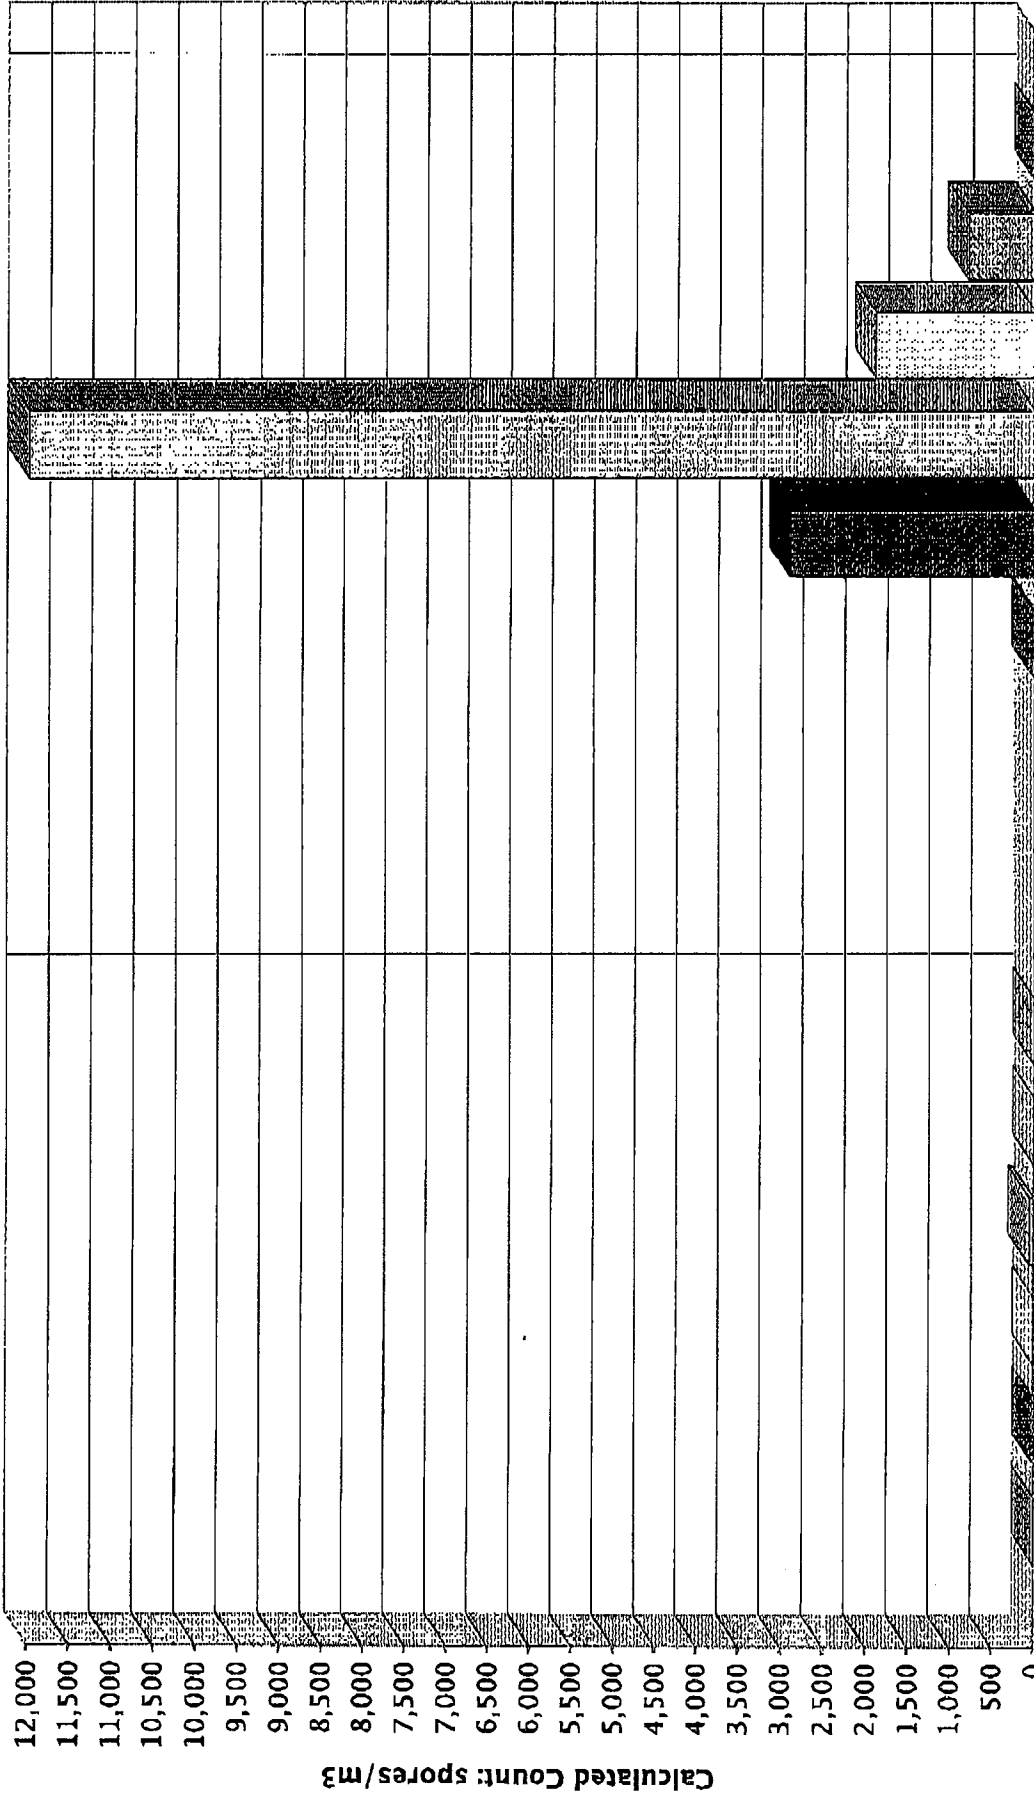
SPORE TRAP REPORT: NON-VIABLE METHODOLOGY

■ Alternaria ■ Ascospores ■ Basidiospores ■ Cladosporium ■ Penicillium/Aspergillus types ■ Rusts

I-14354917: Floor 22 NW corner (near 2232)

J-14354815: Ambient (front entry)

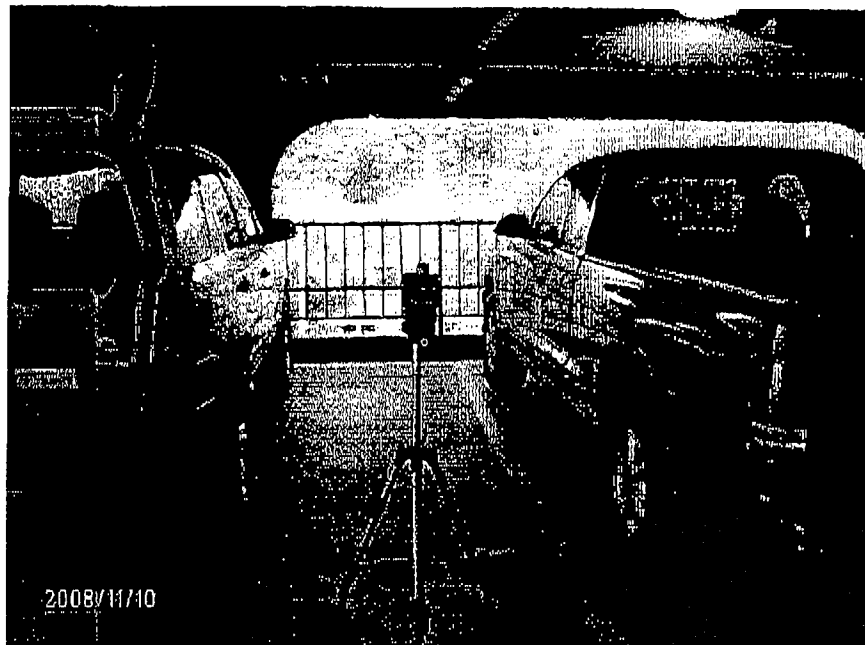
- 1) Image of ambient air sampling location on West side of 3<sup>rd</sup> level garage building structure located at 450 N Street, Sacramento, California (Subject Building) at time of assessment.

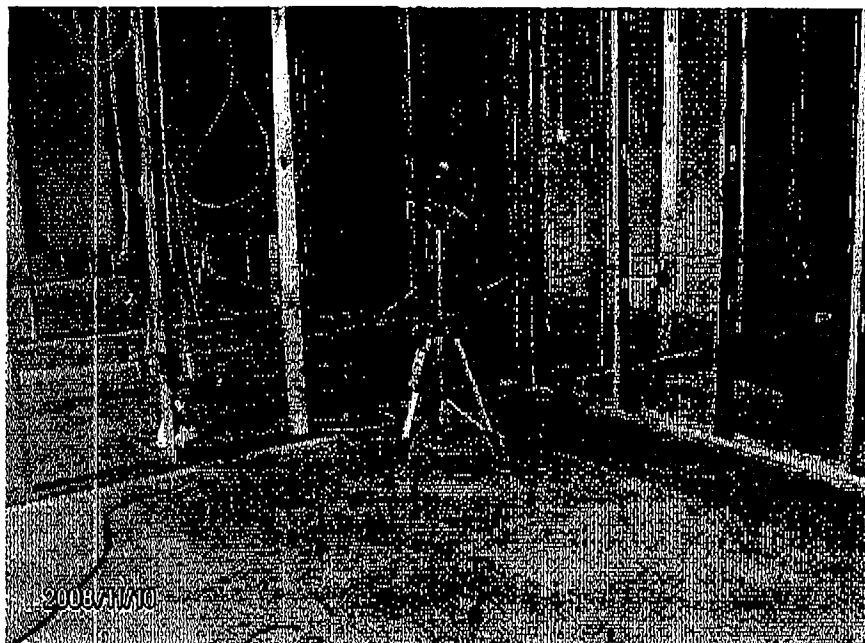
- 5) Image of air sampling activity performed within room 2234 at eastern quadrant of the 22<sup>nd</sup> Floor mitigative area at time of assessment.

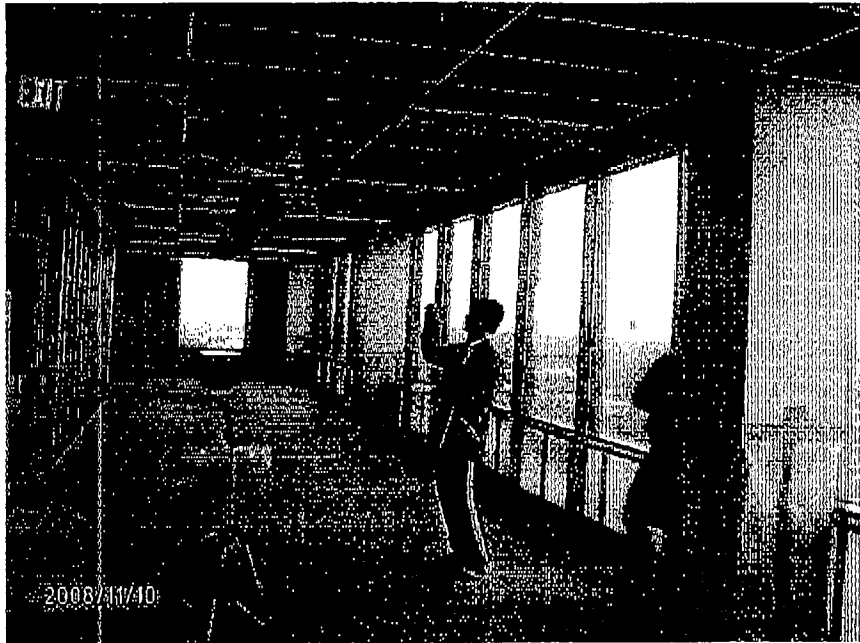
- 7) Image of sampling equipment location within southern perimeter quadrant of 22<sup>nd</sup> Floor mitigative area at time of assessment.

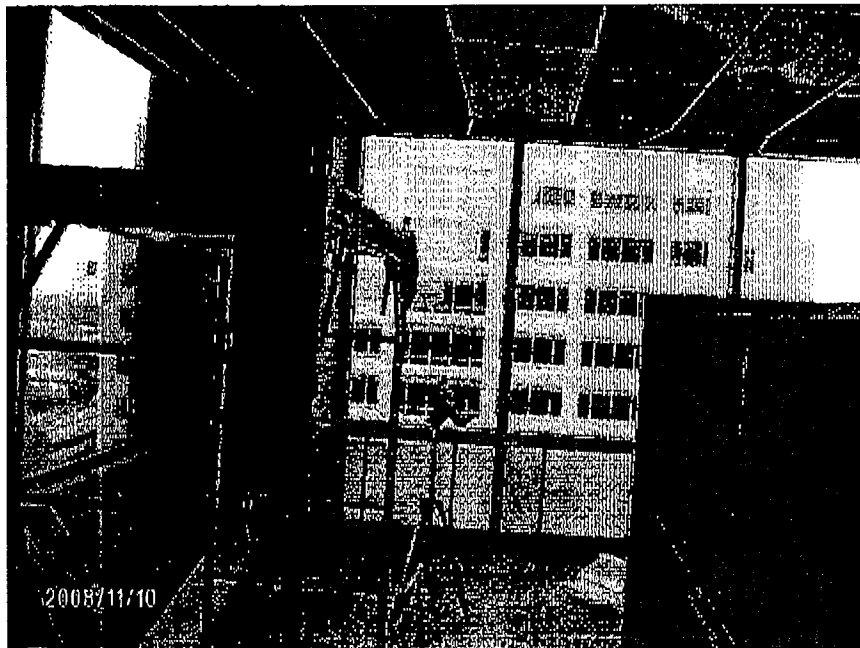
- 8) Image of air sampling performed within northwestern corner area of 22<sup>nd</sup> Floor mitigative area of subject building at time of assessment.

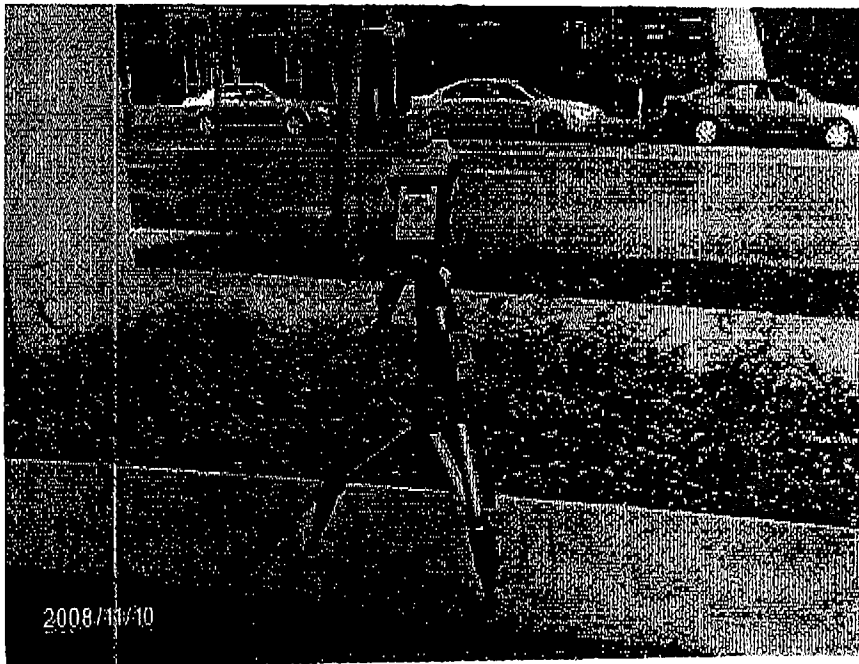
- 10) Image of ambient air sampling performed outside main entry at ground level at the conclusion of interior assessment.
